Manhole Inspection Summary

Manhole # S33KK_053MH

Insp Date: **4/18/07 8:21 AM**

Location Address: **135 FALLS RD**

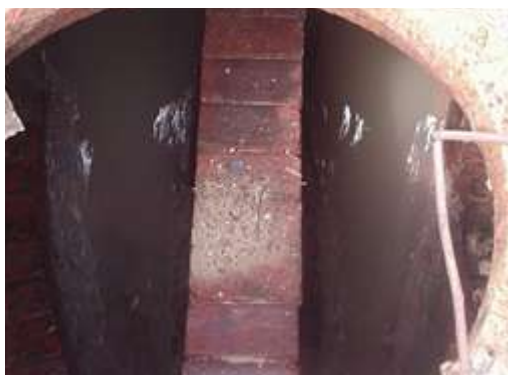
Bench debris.

Drop off in the middle of the MH

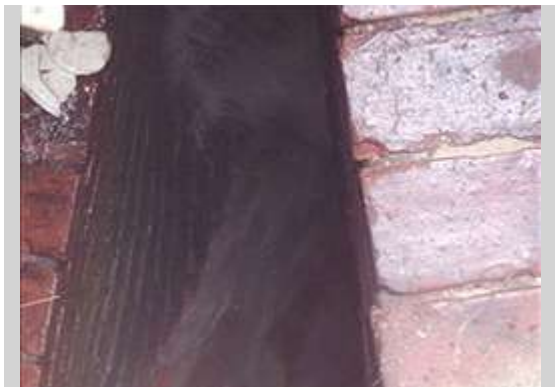
Corroded steps.

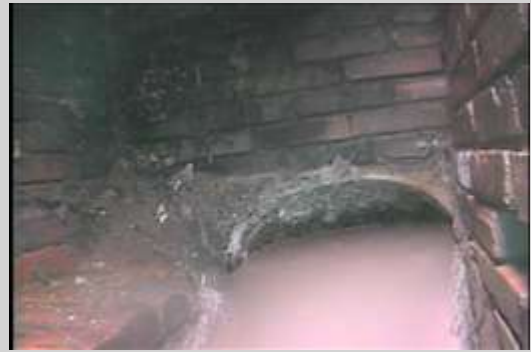
Pipe In @ 5 O'Clock

Barrel deterioration and infiltration.

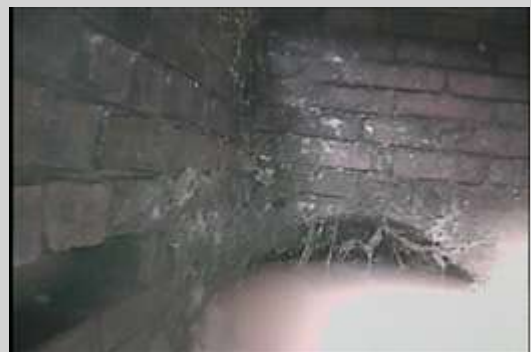
Pipe In @ 7 O'Clock

Barrel deterioration, root intrusion and infiltration.
